THE UNITED STATES
STRATEGIC BOMBING SURVEY

THE EFFECTS
OF
THE ATOMIC BOMB
ON
HIROSHIMA, JAPAN

Volume III

Physical Damage Division

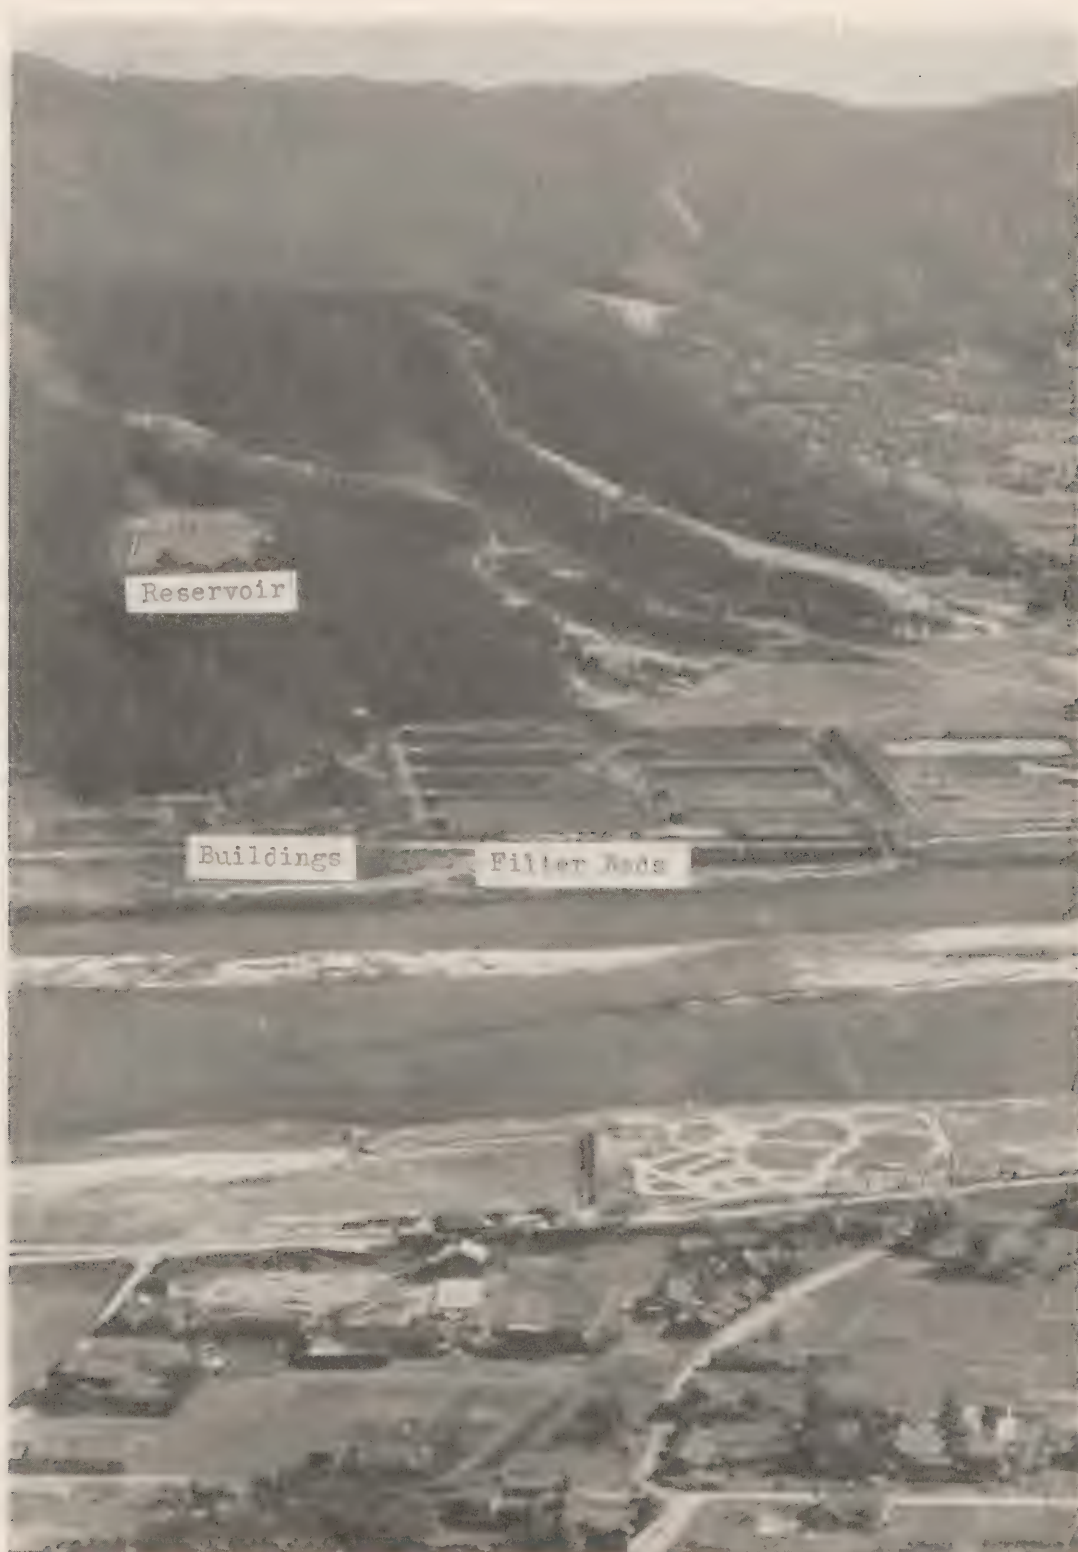
a. The damage to the pumping station (Photo 107) and purification plant (Photo 108), buildings and equipment (Photos 109, 110, and 111), 14,000 and 9,200 feet from GZ, respectively, on 6 August 1945 can be considered as negligible. All damage suffered by buildings (Photo 112) and equipment was by blast. No fires started in this area. Glass panes in all buildings were broken by the blast, as well as window frames, doors, and door frames. Some roof stripping occurred on Buildings 3, 4, and 6 (Photo 113). Sidewall damage occurred to Building 8. All building damage is indicated on Table 28.

PHOTO 112-XIII. General view of purification plant showing buildings, filter beds, and reservoir, 9,000 feet from GZ.

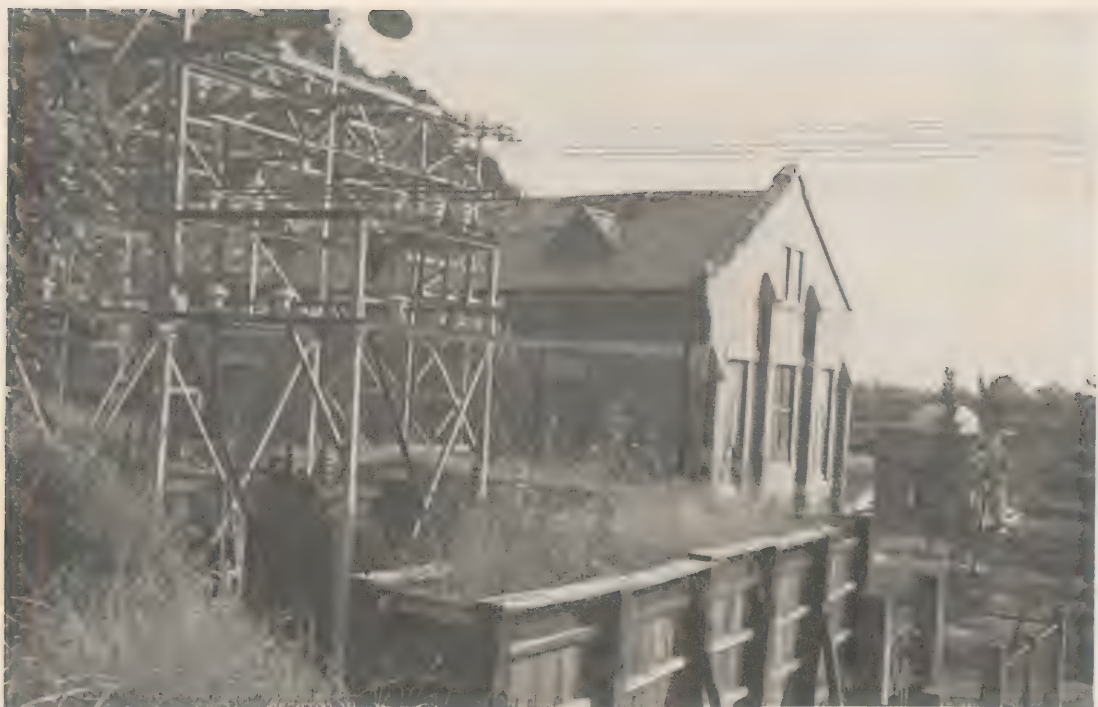
PHOTO 113-XIII. Pumphouse, Building 6, showing light roof stripping. Note electrical substation, 9,000 feet from GZ.

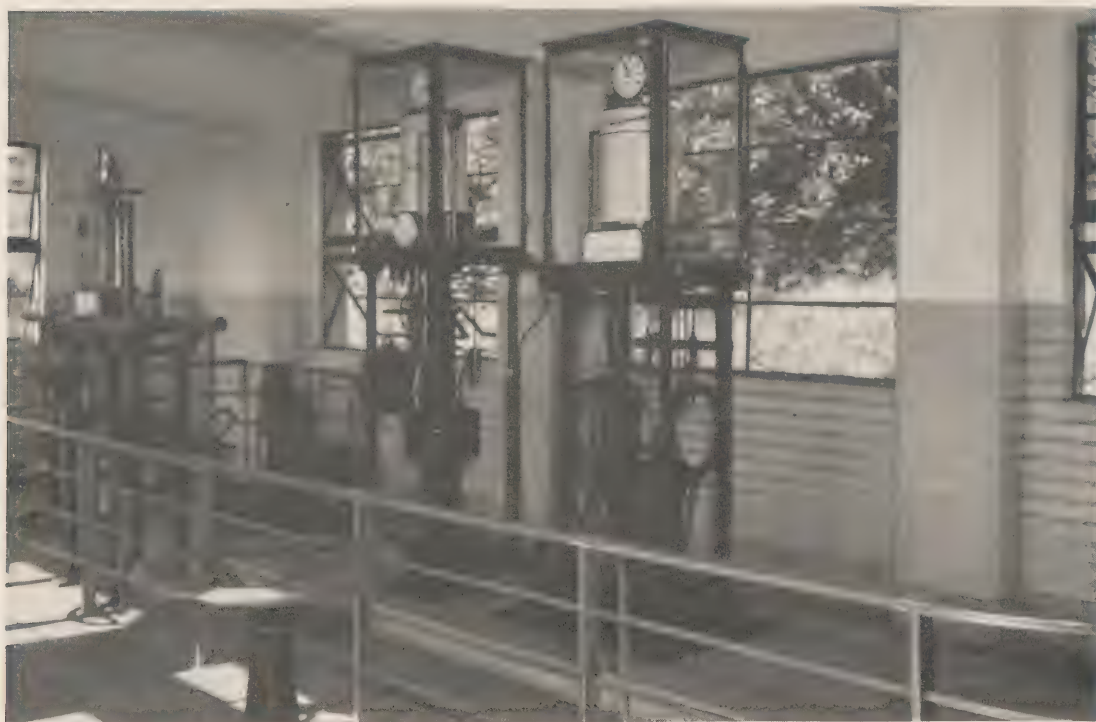
shirt-circuited and burned out as a result. The metering equipment in Building 5 (Photo 114) suffered heavy damage by blast, but the use of the valve system was not impaired.

PHOTO 114-XIII. Damaged meter and recording equipment in Building 5, 9,000 feet from GZ.

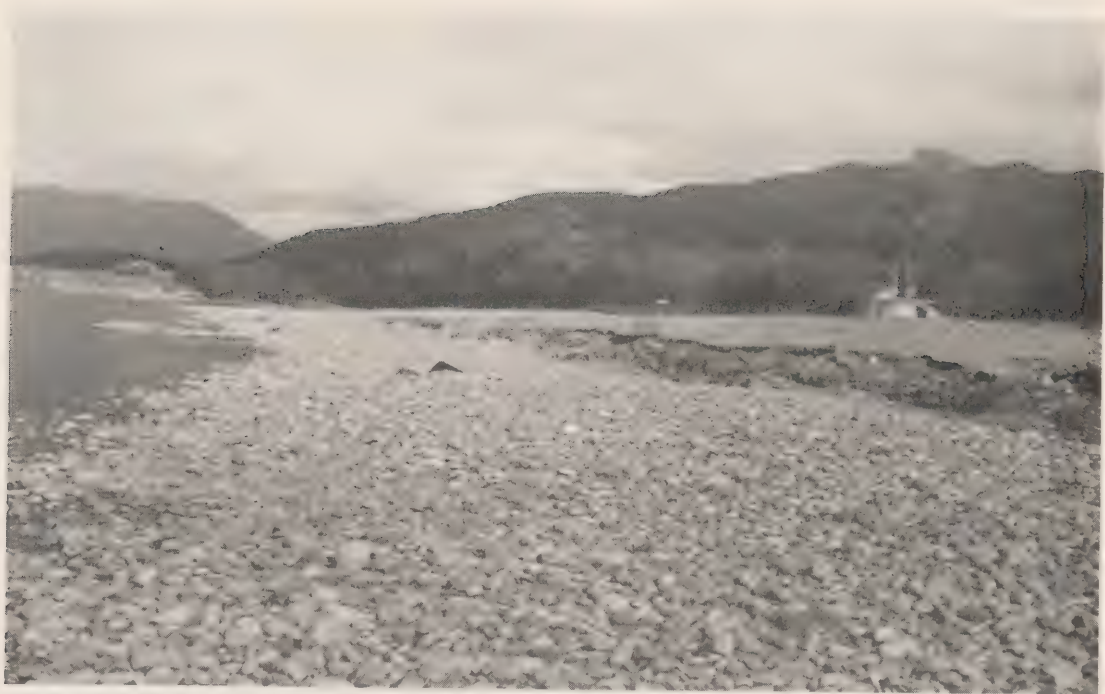
d. The intake (Photo 115), settling basins, filter beds (Photo 116), and reservoir were undamaged. No leaks in piping or mains to or from the intakes, settling basins, filterbeds and the reservoir had been detected. The water in the reservoir, however, dropped to a seriously low level because of leaks in pipes within the city.

PHOTO 115-XIII. Intake system on the Ota River, 14,300 feet from GZ.

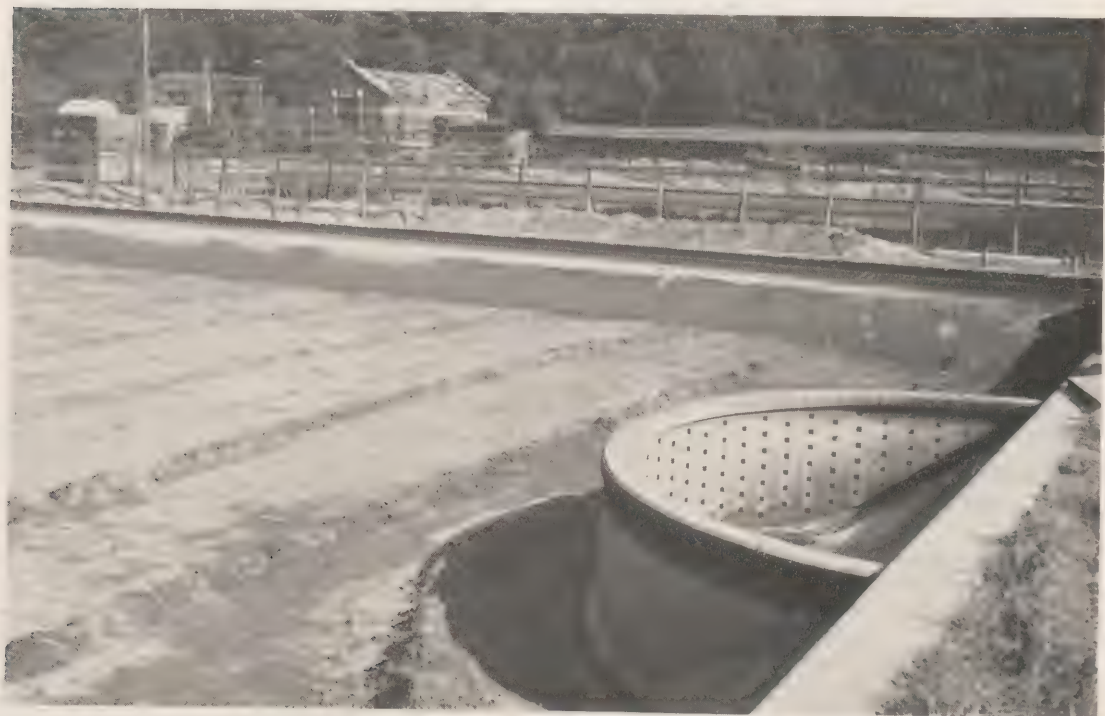
PHOTO 116-XIII. Filter beds being processed. Note roof stripping on Building 6, 9,000 feet from GZ.

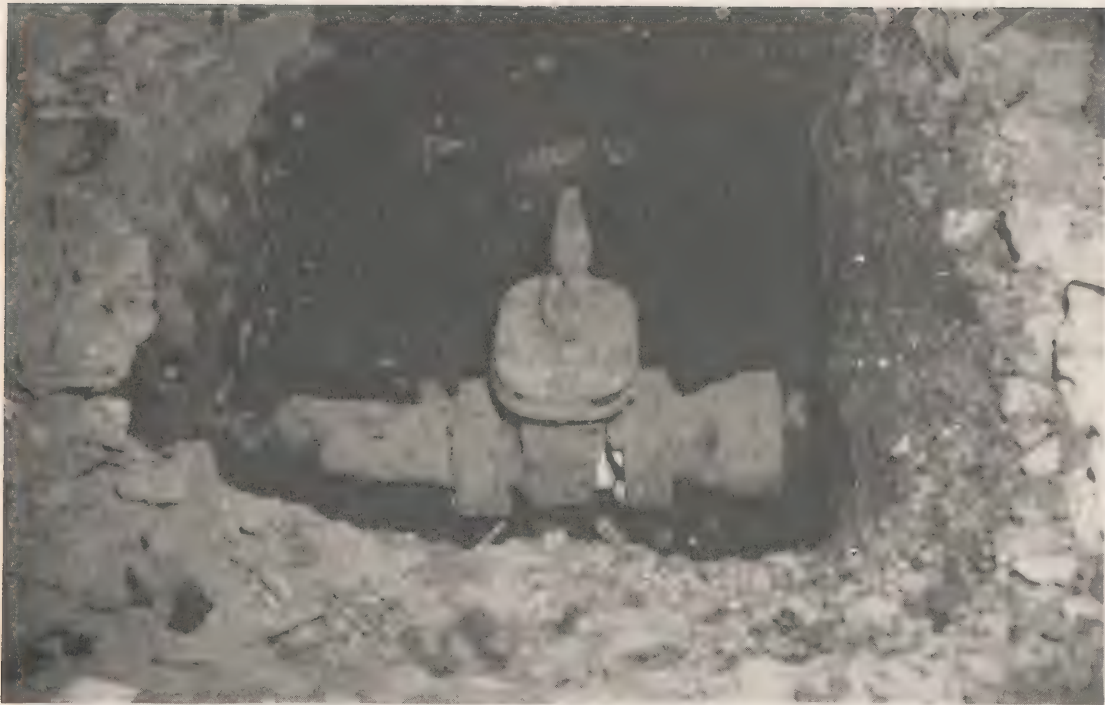
e. Building and equipment damage is summarized in Table 28. With the exception of Bridge 29, which will be discussed in another paragraph, 8 leaks in the water-distribution system (Fig. 16) were found by the water-department officials and were attributed to the blast effect of the atomic bomb. After inspection of leaks 1, 2, and 3 (Fig. 16) in the 16- and 18-inch mains, it was found that leak 1 (Photo 117) was in a 4-inch diameter, cast-iron lateral, directly over a 16-inch main, broken at the valve body by a falling 19-inch brick wall from an adjacent building. Leak 3 (Photo 119)

PHOTO 117-XIII. Leak 1. Four-inch gate valve broken by debris from 19-inch brick wall, 1,100 feet from GZ.

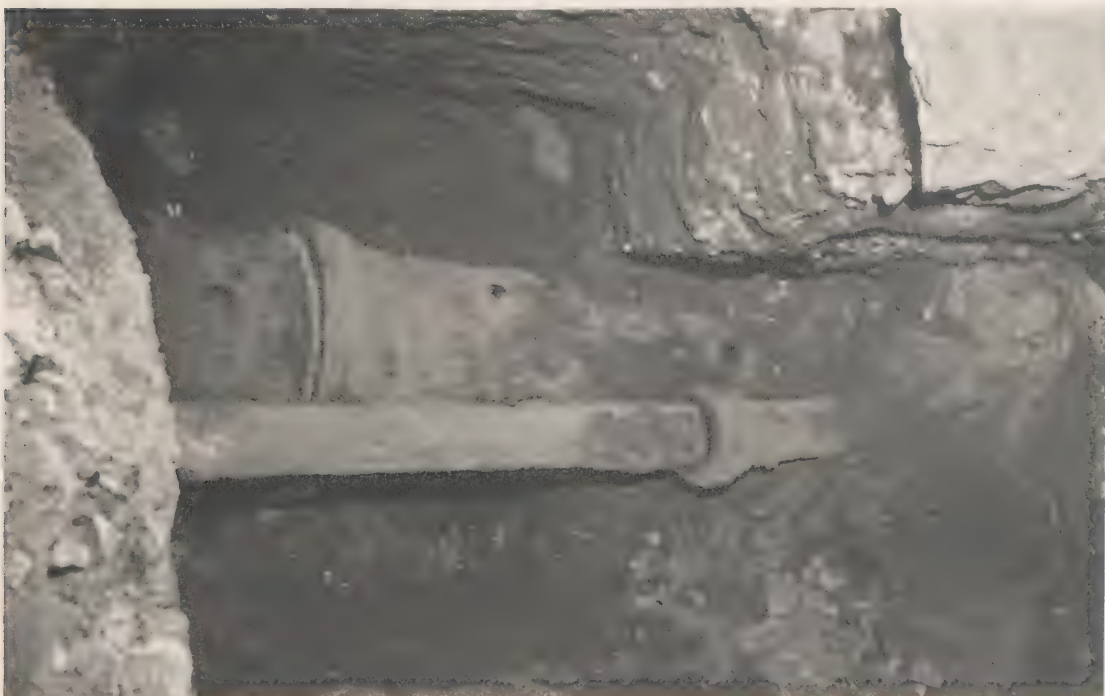
PHOTO 118-XIII. Leak 2, 100 feet from GZ. Lead-caulking seal broken in 16-inch main; 4-inch main undamaged.

was a cracked street L connected to a 7-inch lateral damaged by the movement of the building serviced, and leak 2 (Photo 118) was a break in the lead-caulked seal of an 18-inch main, which could have been caused by the bomb blast, as the main was only 100 feet from GZ, but, in view of the severe action induced in Bridge 22 by the blast, it is more probable that the bridge movement caused this leak, otherwise, a series of leaks would have occurred from the bending action in the mains, occasioned by blast pressure. There was no crushing of the mains at any place. Leaks 4 (Photo 120) and 5 were also caused by falling debris but leaks 6, 7, and 8 did not result from the atomic-bomb attack. It was estimated that 70,000 branches or leads were damaged as a result of blast or fire damage to dwellings and other buildings. Because of the great number of open pipes the pressure of a normally low-pressure system dropped to zero.

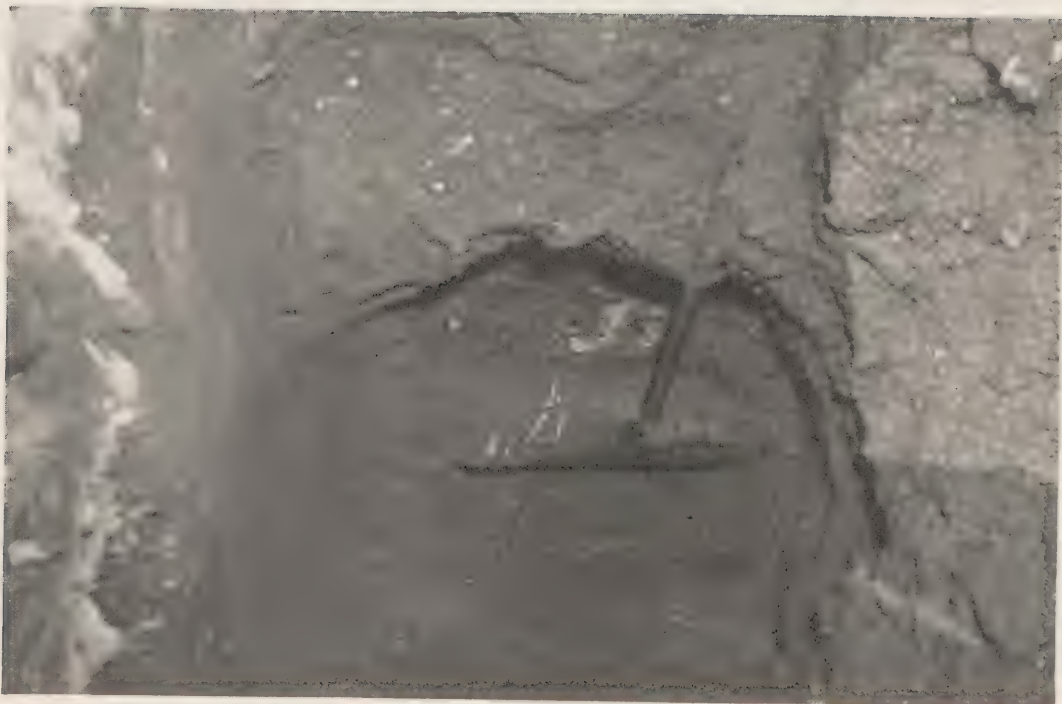
PHOTO 119-XIII. Leak 3. Street L cracked by building movement, 600 feet from GZ.

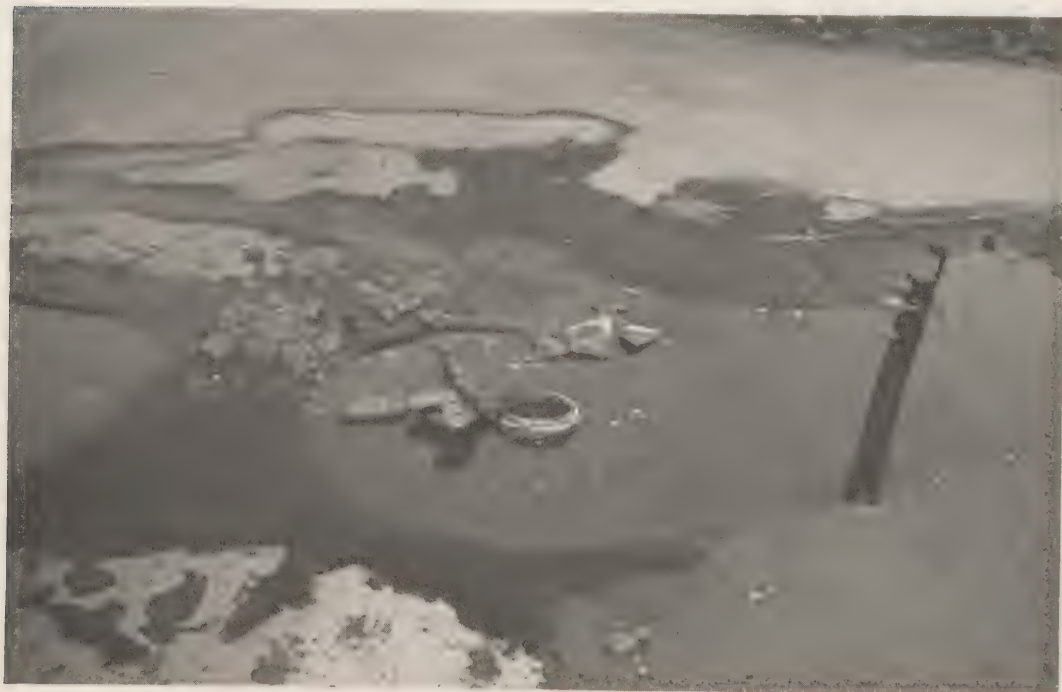
PHOTO 120-XIII. Leak 4 caused by falling debris, 3,100 feet from GZ.

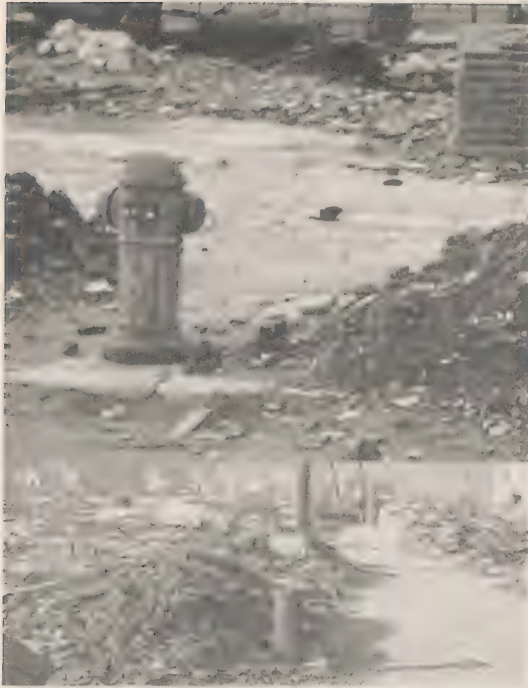
f. With the exception of one valve, referred to previously, all valves were undamaged. A few standard, above-ground hydrants (Photo 121) were damaged by falling debris but no flush-type hydrants (Photos 122 and 123) were damaged. Because of the great number of damaged branches, however, residents pushed the balls of the flush-type hydrants from the seats allowing water to flow for their personal use (Photo 123). After all leaks had been closed off in mains and laterals and in all branches or leads that could be reached, the distribution pressure within the city was brought up to 15 pounds per square inch, but even then 16,000,000 gallons of water per day were required to supply the city. As there were no requirements for water in the city center, that part of the system was discontinued.

PHOTO 121-XIII. Standard-type hydrants. Lower view, damaged by debris, 3,600 feet from GZ.

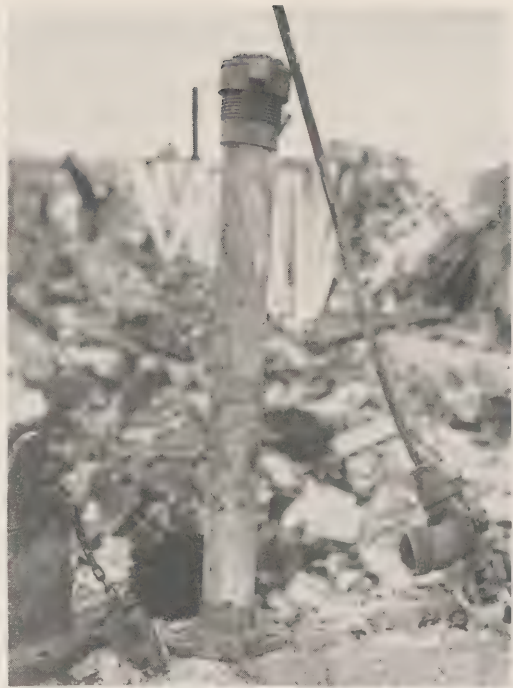
PHOTO 122-XIII. Flush-type hydrant with operating rod. Damaged in warehouse fire.

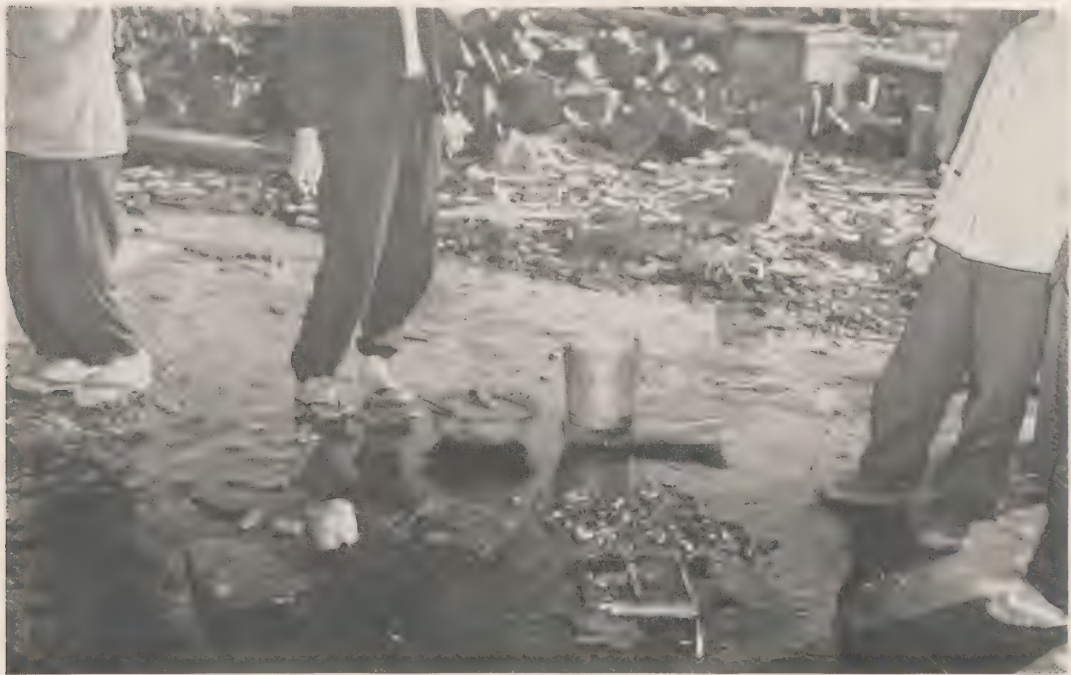
PHOTO 123-XIII. Residents using water from flush type hydrant, when ball valve was pushed from seat, 3,500 feet from GZ.

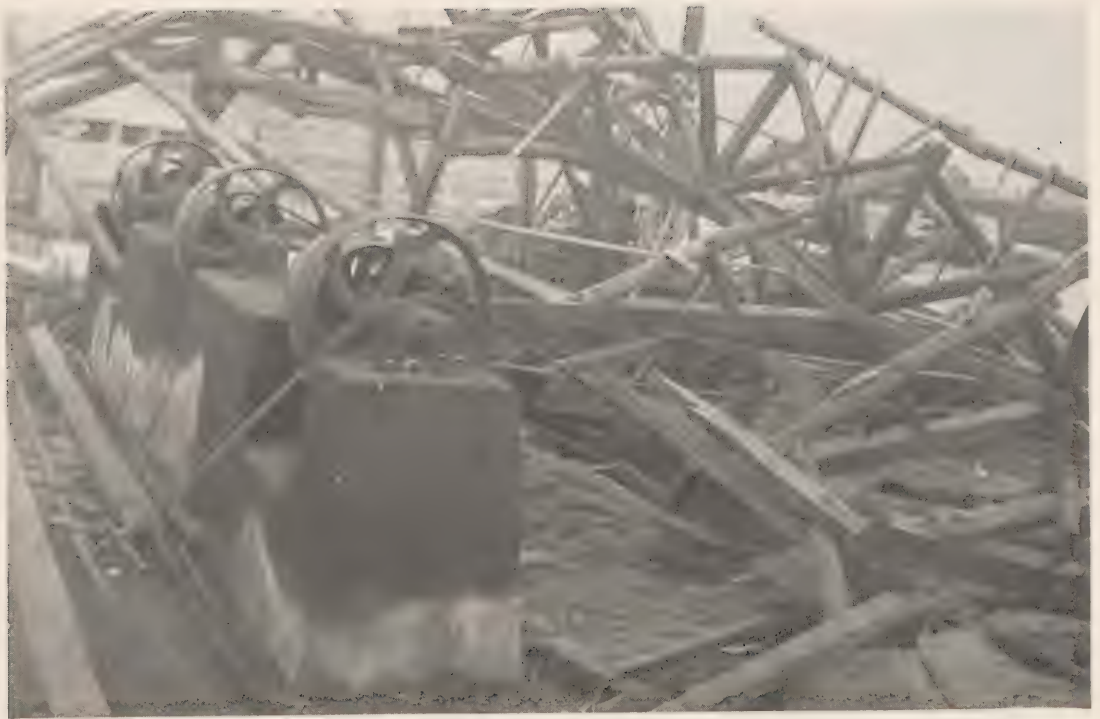
g. The booster pump station at Koi, 8,000 feet from GZ, was undamaged. Buildings at stations 1 (Photo 124) and 2 (Photo 125) however, 6,600 and 5,600 feet, respectively, from GZ, received structural damage by blast. Apart from the electrical panel damage, no other equipment damage resulted from the blast. The pumping station at the Army Divisional Headquarters, 4,600 feet from GZ, sustained the same amount and type of damage as booster pump Stations 1 and 2. No effort had been made to place the booster pump stations or the Army headquarters pump station in operation.

PHOTO 124-XIII. Booster pump station 1. Blast damage to building and equipment, 7,100 feet from GZ.

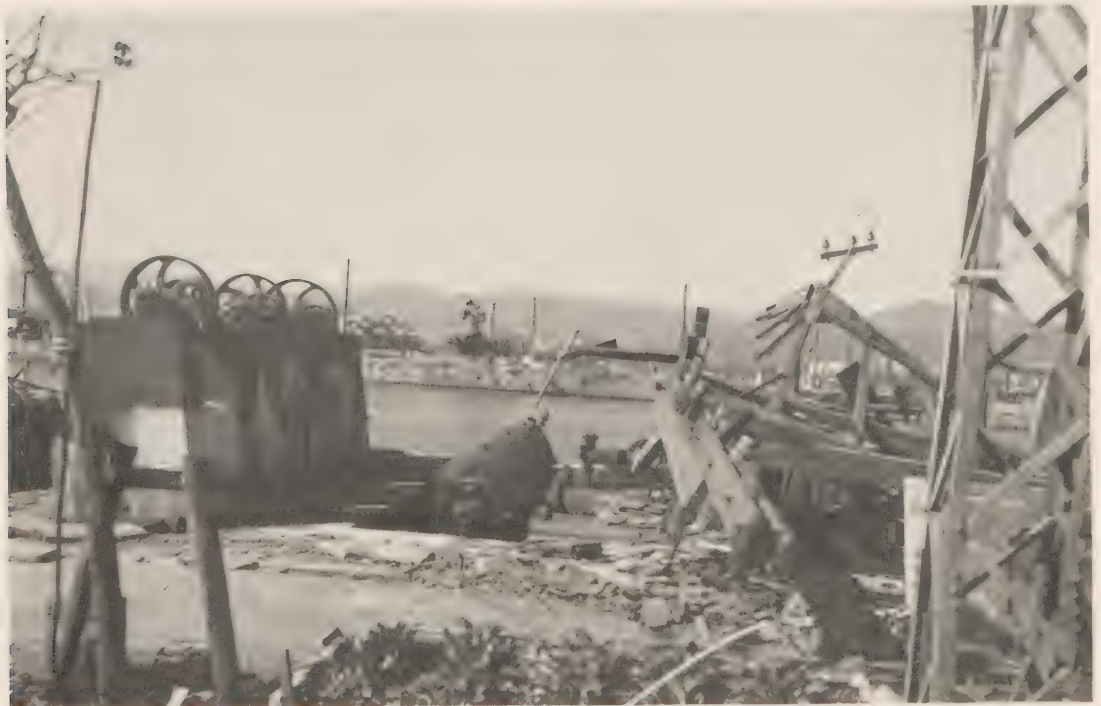
PHOTO 125-XIII. Booster pump station 2. Blast damage to building and equipment, 5,900 feet from GZ.

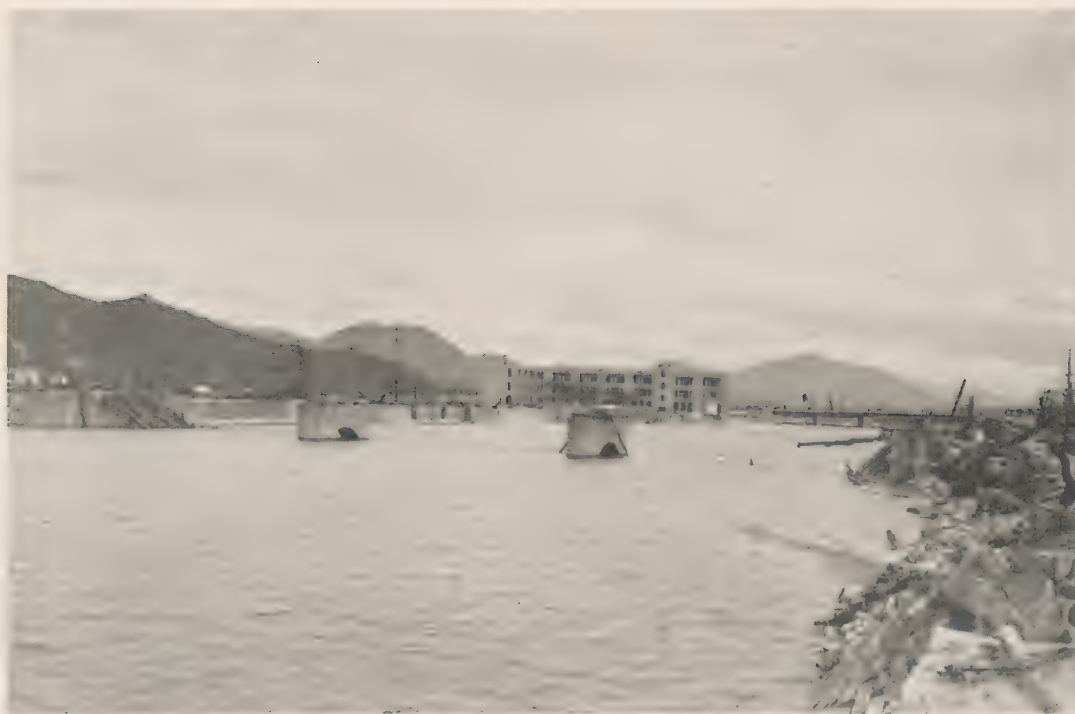
h. Bridge 29 (Photo 126), referred to in a preceding paragraph, was the only bridge acting as

a water crossing (Photo 127) that was totally damaged directly by blast. This damage did not deprive the area west of the Ota River of water since there was another 16-inch crossing within the same loop. Bridge 43 (Photo 130) was damaged by blast and fire, depriving of water the section served by it. Bridge 43 was repaired in October 1945. There was some movement in Bridge 22 caused by blast which broke the seal of leaks (Fig. 16) but not sufficiently to cause interruption of any service. The angle-chord members of Bridges 30A (Photos 128, 129) were twisted by the blast, but the 16-inch main was undamaged and no leaks were noted. The floods of 17 September 1945 and 5 October 1945, however, damaged four bridges (Photos 131, 132, and 133) to such an extent as to impair their use as water overcrossings. The following Table 32 is a summary of bridge damage as given by the Bridge Damage Section:

d. The damage by blast to Bridge 29 interrupted the service of the 16-inch water main that crossed the Ota River at that location, but other crossings in the same area and in the same loop assisted in supplying water to the area. The twisted members of Bridge 30A indicated that considerable damage was received. Had it not been that the strength of the structure was augmented by the 16-inch water

PHOTO 126-XIII. Bridge 29 carrying water main, damaged by blast, 1,200 feet from GZ.

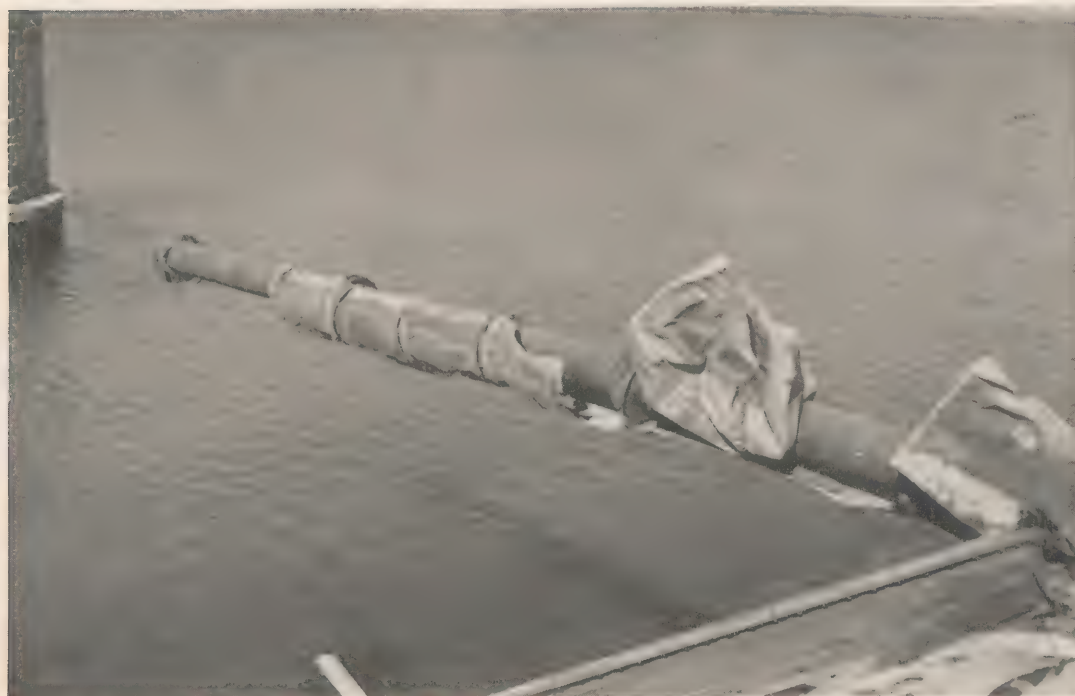
PHOTO 127-XIII. Section of 16-inch water main at Bridge 29, 1,200 feet from GZ.

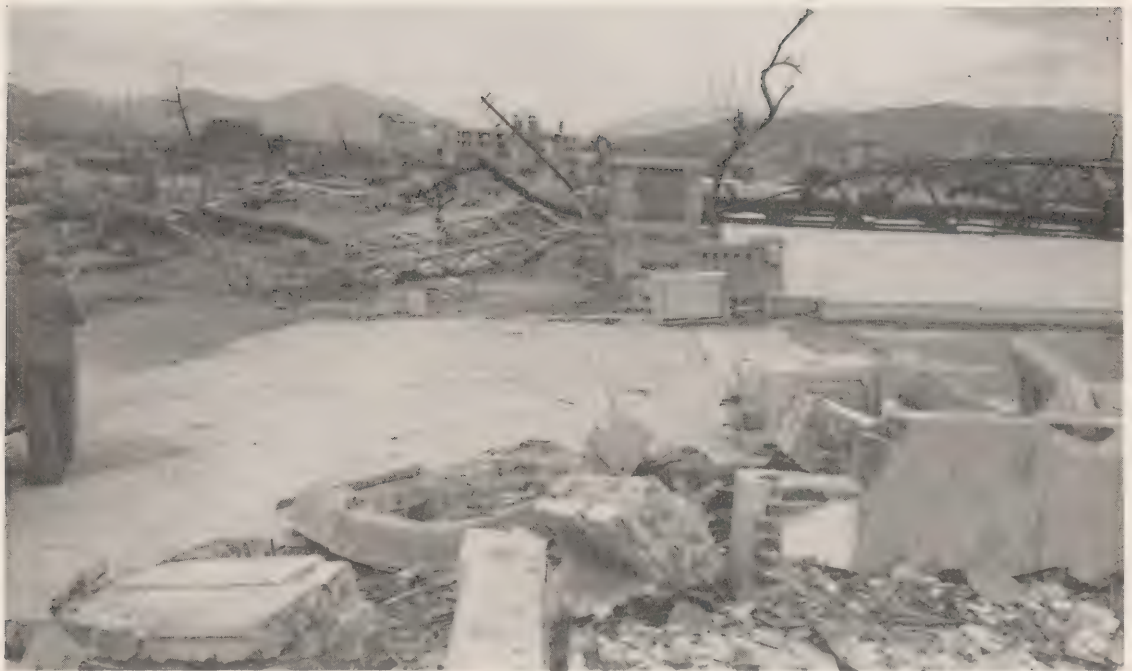
PHOTO 128-XIII. West abutment of Bridge 30A showing minor damage, 1,900 feet from GZ.

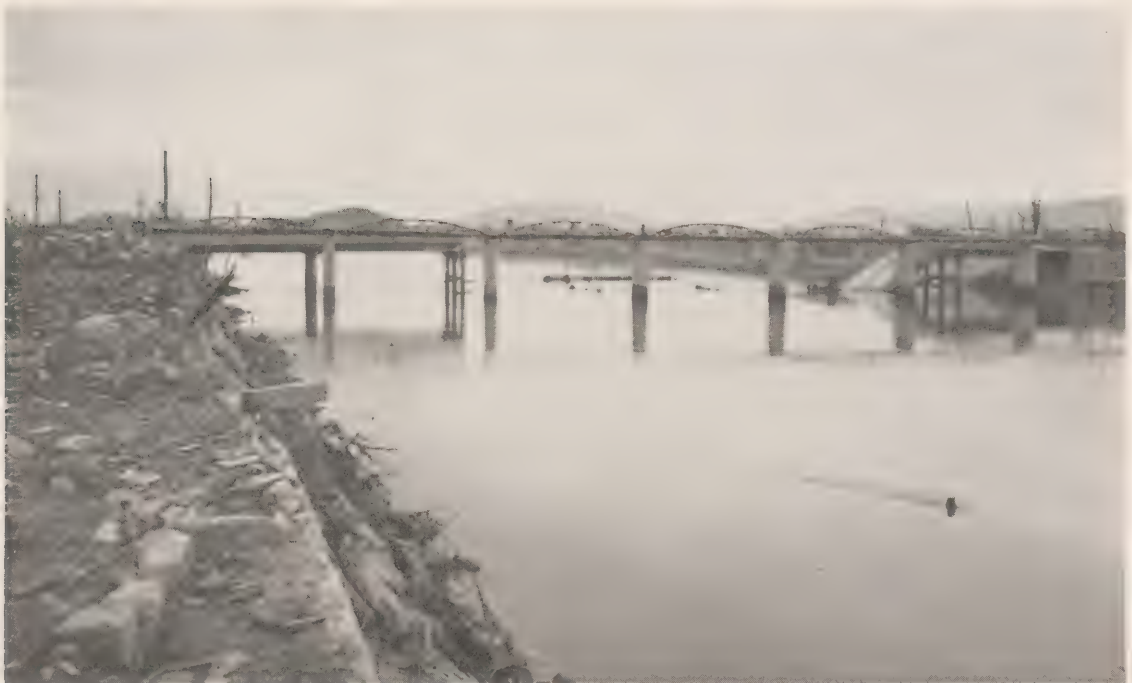
PHOTO 129-XIII. Blast-damaged aqueduct (Bridge 30A) carrying 16-inch water main, 1,900 feet from GZ.

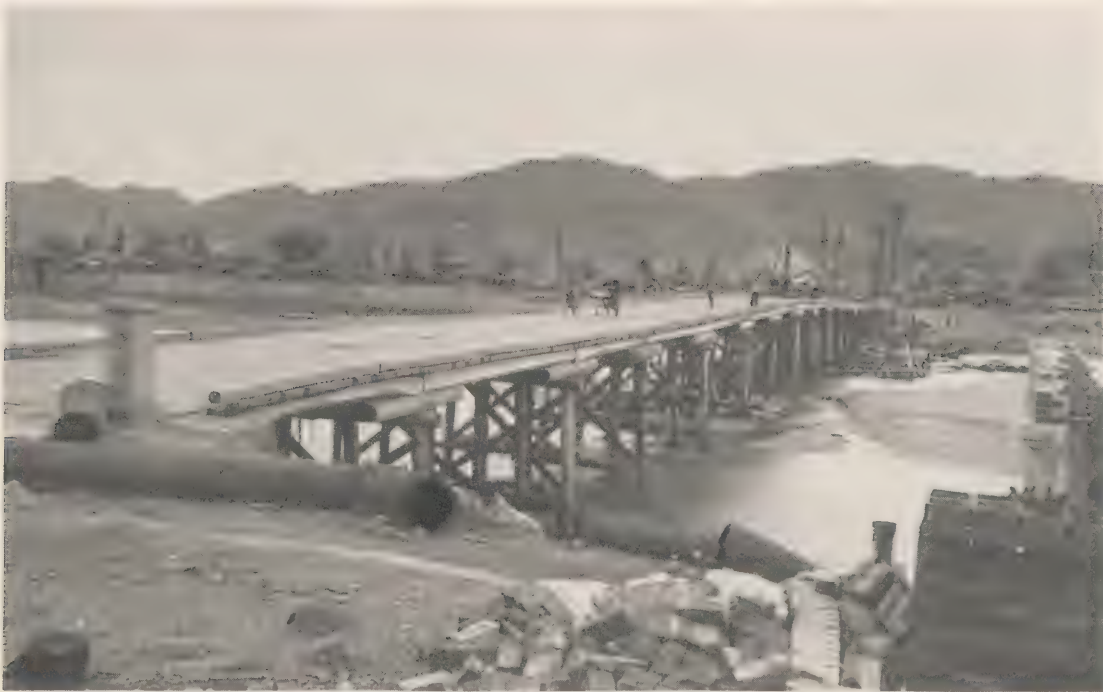
PHOTO 130-XIII. Bridge 43 rebuilt, October 1945. Original bridge carrying 14-inch water main, structurally damaged by blast and fire, 5,200 feet from GZ.

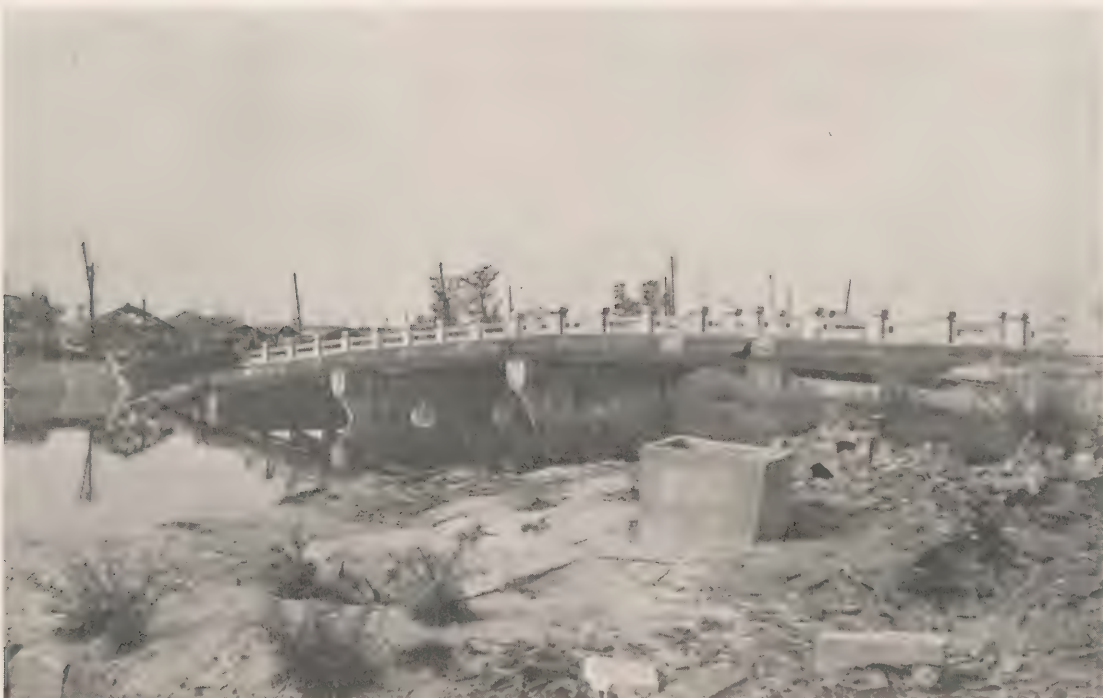
It will be noted that more damage resulted from the floods than from the atomic-bomb attack.

PHOTO 131-XIII. Flood damage to Bridge 3 carrying 16-inch main, 7,100 feet from GZ.

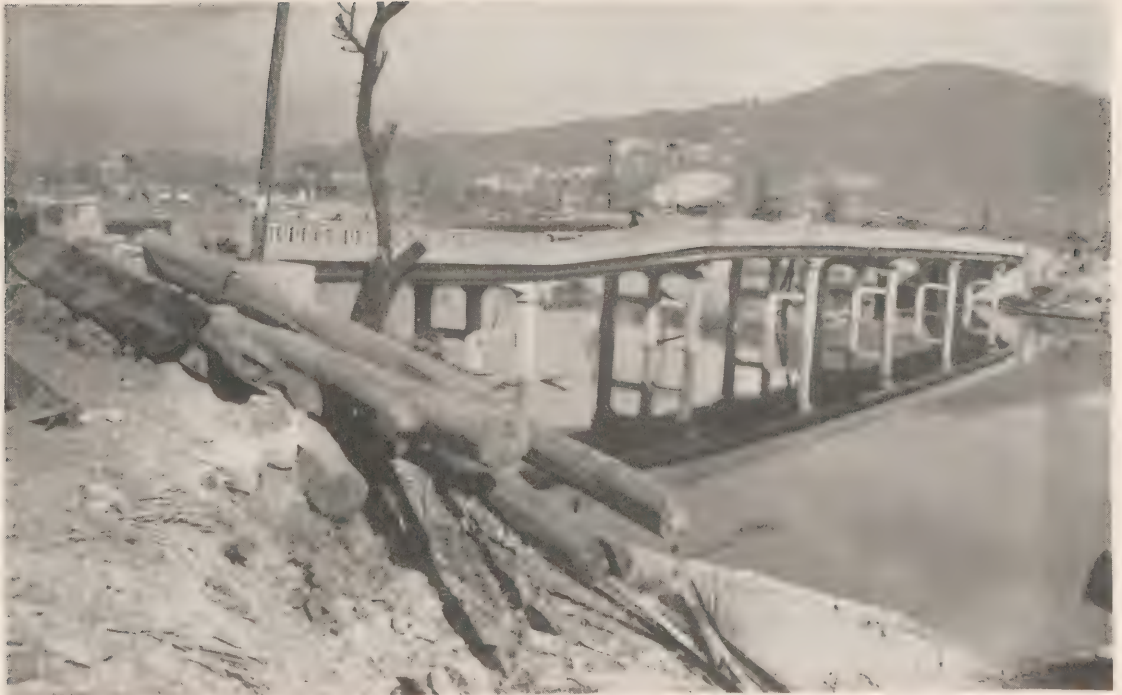
PHOTO 132-XIII. Flood damage to Bridge 10 carrying 20-inch main, 7,000 feet from GZ.

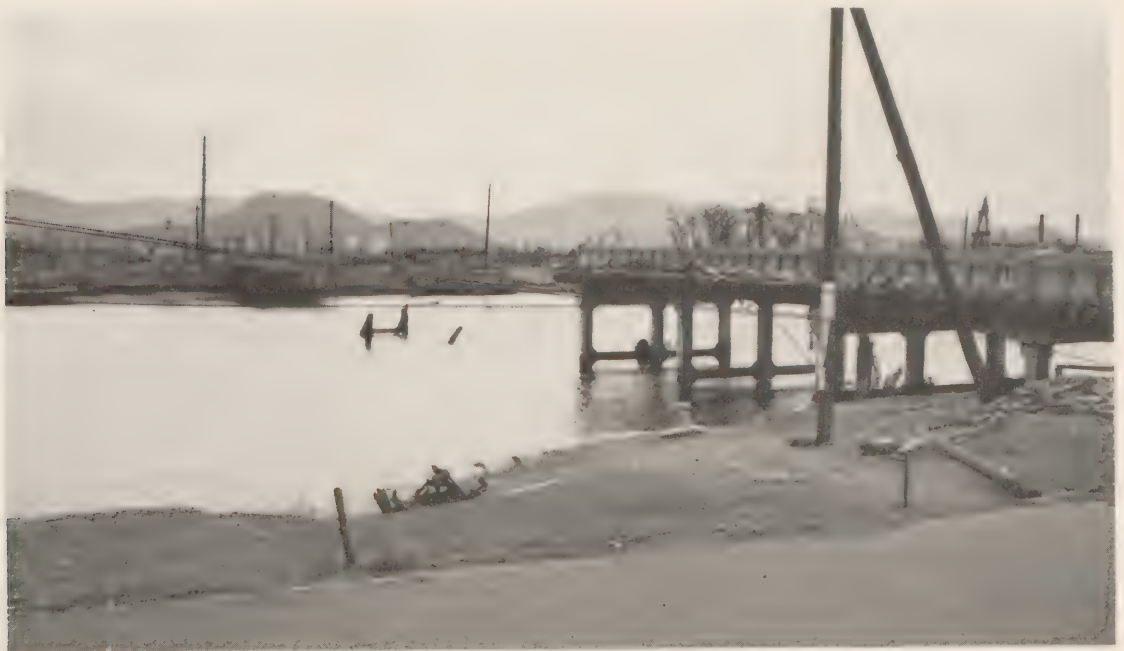
PHOTO 133-XIII. Flood damage to Bridge 31 carrying 16-inch main, 4,500 feet from GZ.

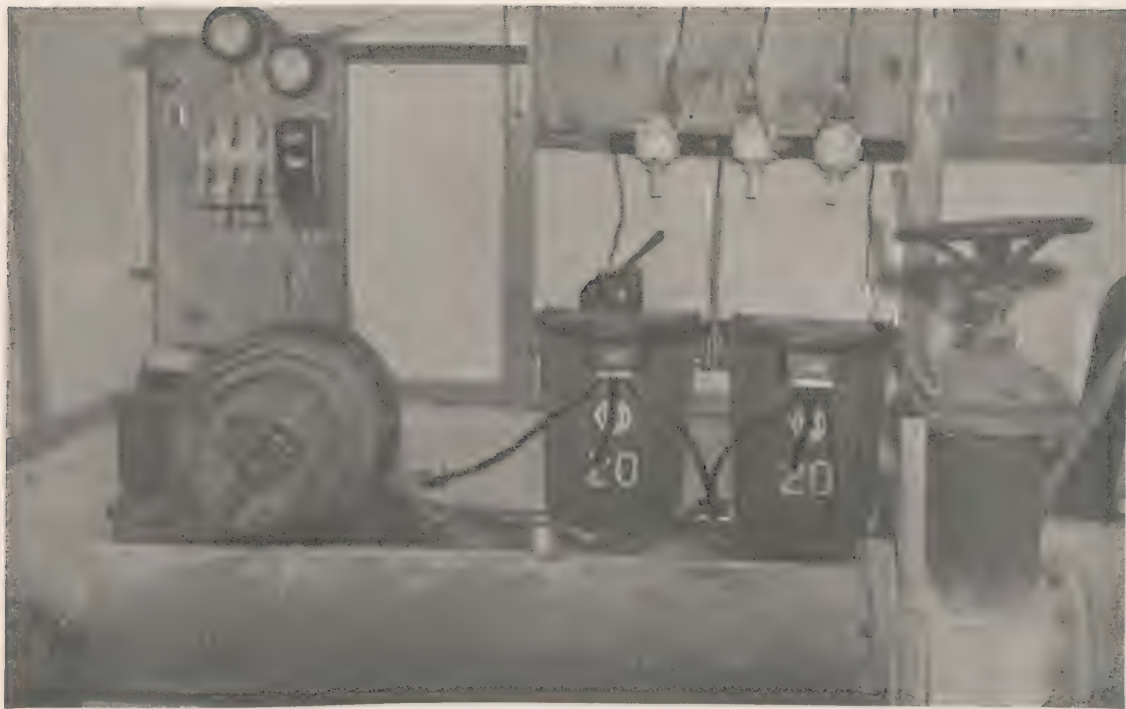
b. It will be noted that the electric-motor damage of Stations 1 (Photo 135) and 5 is classified as heavy, the cause being that plaster and debris fell in the motor rotors while in operation, resulting in a severe short circuit and burning of the coils. Stations 12 (Photo 136) and 13, damaged by blast, suffered small-panel and incidental-equipment damage, insufficient to prevent operations. Since Station 12 was under construction and all equipment was not installed, however, it was not considered as being in operative condition. The equipment in the four electrically operated stations (6, 7, 10, and 14) which were damaged by fire (Photos 137, 138, and 139) was rendered totally useless as was that in gas-fuel-operated Station 9 (Photo 140). The operational value of the pumps in the fire-damaged stations was rendered negli-

PHOTO 135-XIII. Equipment for Sewer Pumping Station 1. Motor damaged by debris, 16,900 feet from GZ.

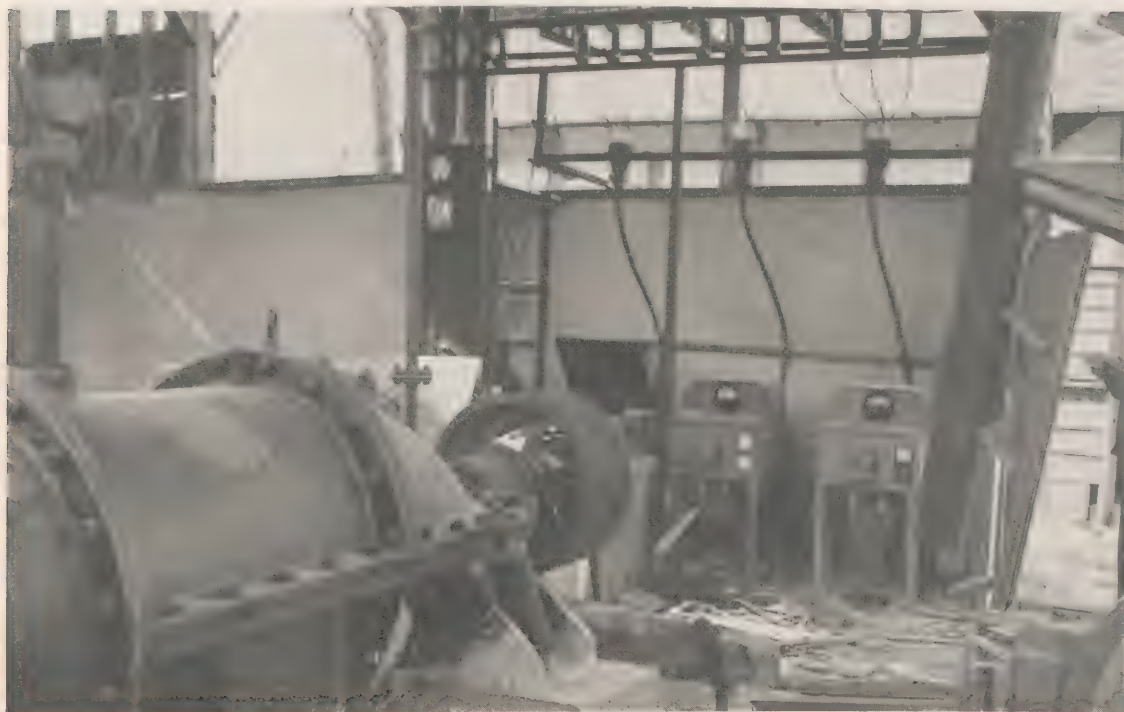
PHOTO 136-XIII. Damaged equipment in sewer pumping station which was 11,600 feet from GZ.

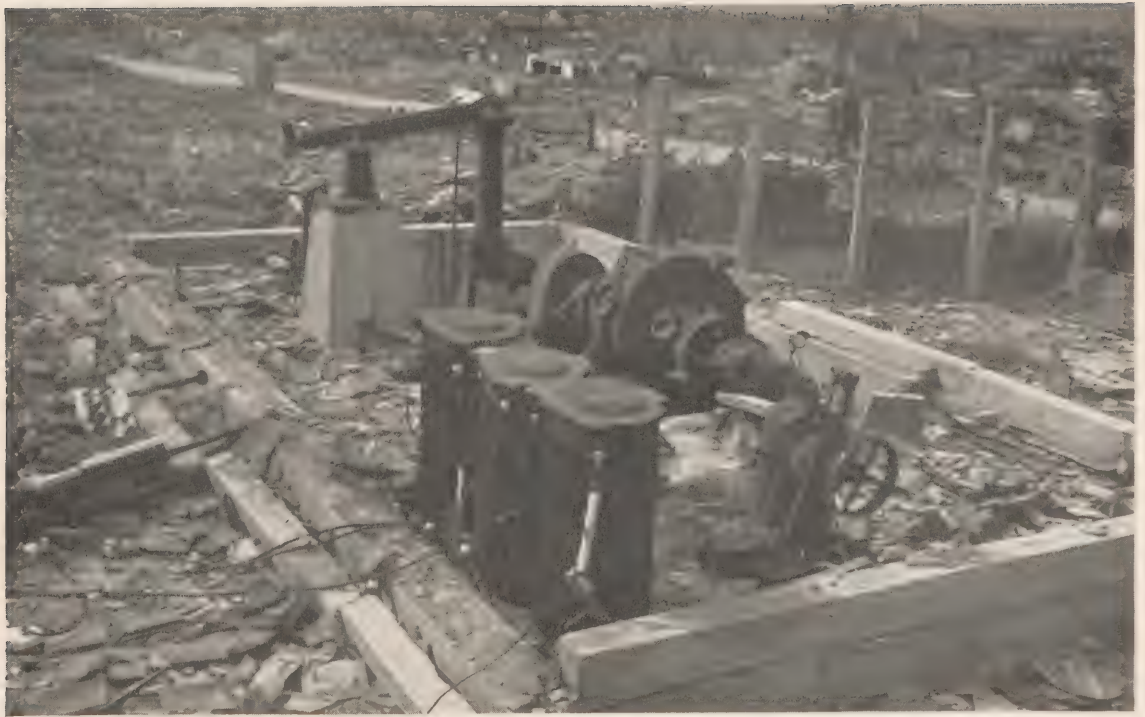
e. Of the 14 frame structures erected to house the pumping equipment, five were damaged by fires (Photos 137, 139, and 140) and 9 were damaged by blast (Photos 141, 146, 147, 148, and 149). Table 35 gives the extent of damage to all pump station buildings. The wood-frame type structures constructed for the pumping stations were typical Japanese construction and could be readily replaced if damaged.

PHOTO 137-XIII. Fire Damage to Sewer Pumping Station 7, located 5,200 feet from GZ.

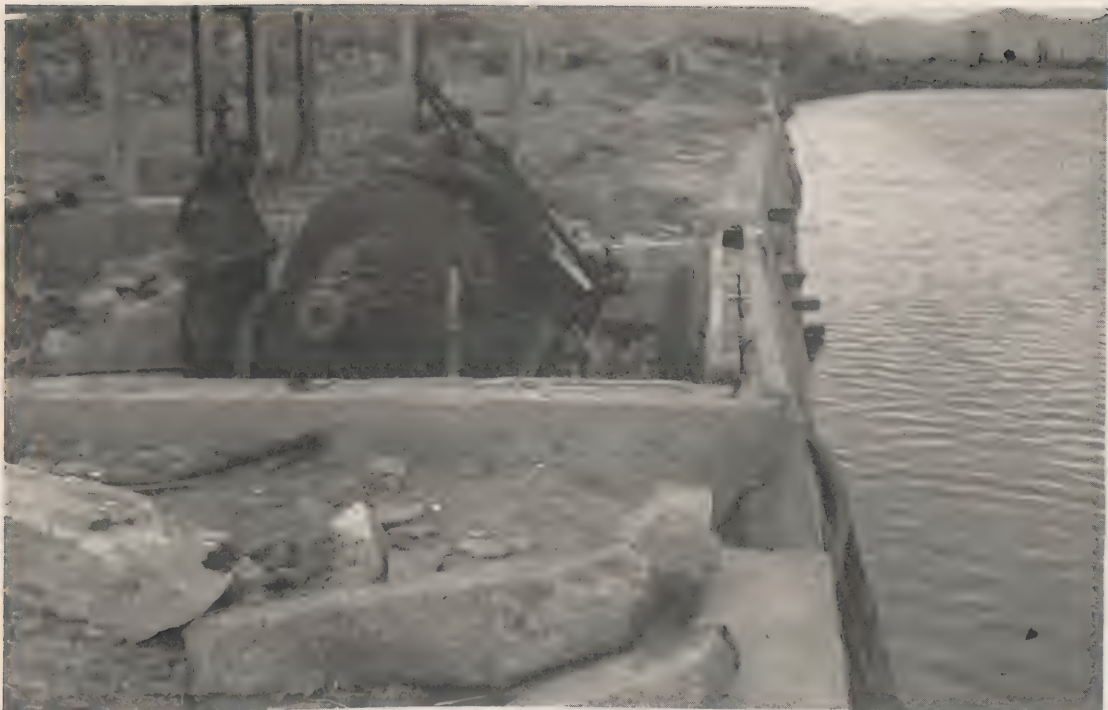
PHOTO 139-XIII. Fire damage to Sewer Pumping Station 14, situated 2,800 feet from GZ.
